# Manhole Inspection Summary

Manhole # S21O\_\_009MH

Insp Date: **3/13/08 8:52 AM**

**Location** Address: **616 s monroe-payson alley**

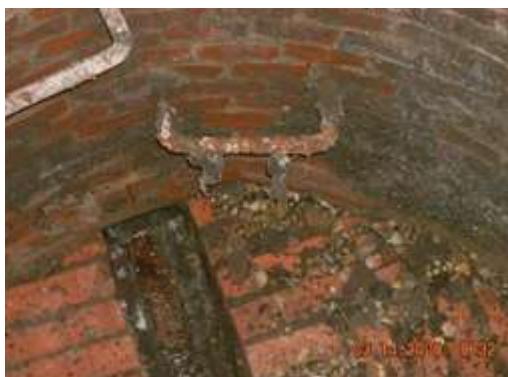
Defect 1

**Surcharge** ☒ **Evidence Of Surcharge** Depth: **2.5** (ft.) ☐ Active Surcharge Present

surcharge evidence on bottom step

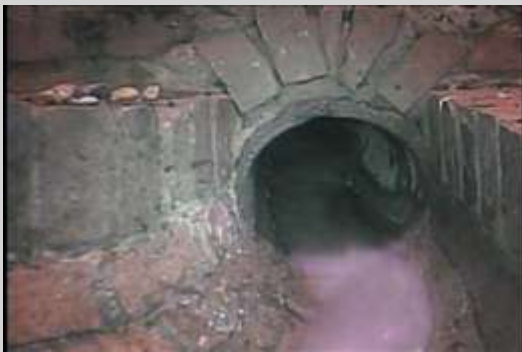
12 O'Clock Outflow

8 in. Circular Gravity Sewer  
Pipe Out @ 12 O'Clock

Pipe Height: **8.4** (in.) Rod and Bar (Angled)  
Pipe Material: **Clay** ☐ Pipe Lined  
Invert Depth: **8.27** (ft.) Flow Characteristics: **Slow**  
Deposits: ☒ None ☐ Mud ☐ Sludge ☐ Debris ☐ Grease  
Silt Depth: **0** (in.) Deposits Extent:  
Infiltration: **None** Pipe Seal Cond: **Sound**

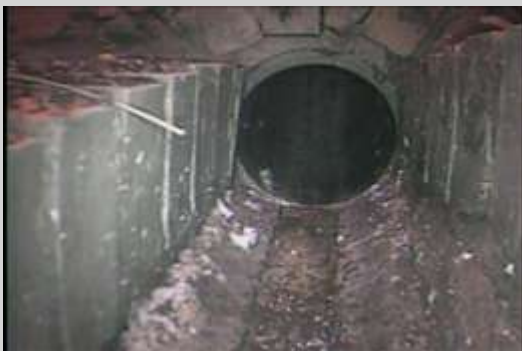
6 O'Clock Inflow

6 in. Circular Gravity Sewer  
Pipe In @ 6 O'Clock

Pipe Height: **6** (in.) Rod and Bar (Angled)  
Pipe Material: **Clay** ☐ Pipe Lined  
Invert Depth: **7.94** (ft.) Flow Characteristics: **None**  
Deposits: ☒ None ☐ Mud ☐ Sludge ☐ Debris ☐ Grease  
Silt Depth: **0** (in.) Deposits Extent:  
Infiltration: **None** Pipe Seal Cond: **Sound**

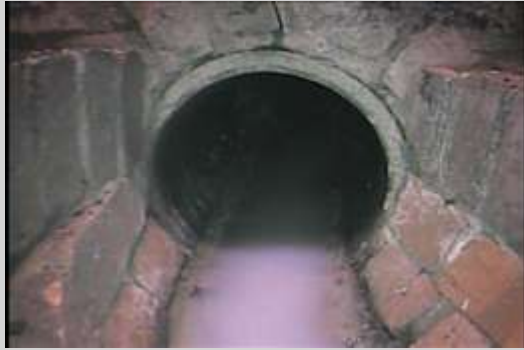
9 O'Clock Inflow

8 in. Circular Gravity Sewer

Pipe In @ 9 O'Clock

Pipe Height: **8.4** (in.) Rod and Bar (Angled)

Infiltration: **None** Pipe Seal Cond: **Sound**
